Home Inspection Report Structural Pest Inspection Report WSDA Inspection Control Number 4533AQ011

Client(s): Sample

Property address: 1234 Sample Dr W
Sammamish WA 98074-6303

Inspection date: Saturday, November 08, 2014

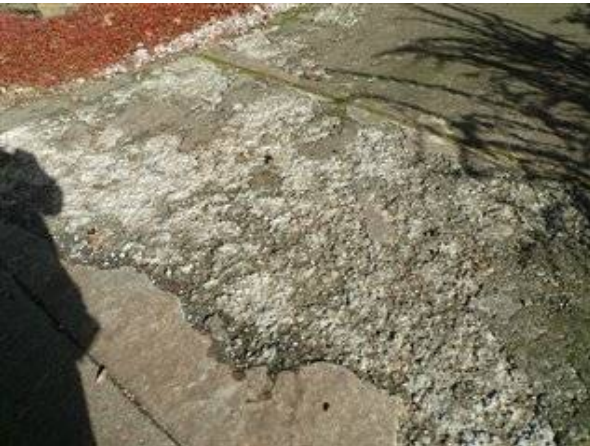
Photo 3-1

3) *Repair/Maintain* - Cracks, holes, settlement, heaving and/or deterioration were found in the driveway. Recommend that a qualified contractor repair as necessary.

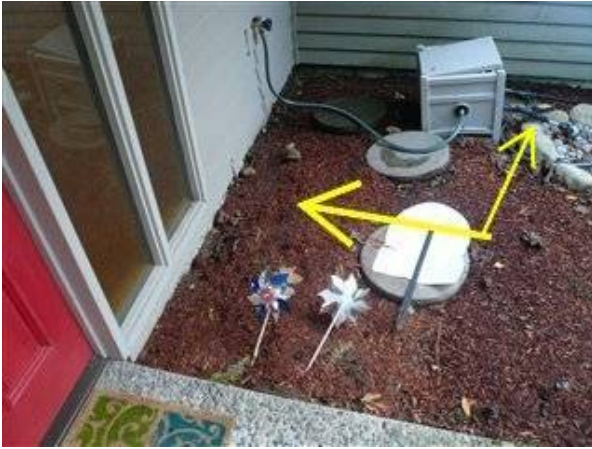
Photo 4-1

4) *Maintain, Conducive conditions* - The soil or grading sloped down towards building perimeters in one or more areas. This can result in water accumulating around building foundations or underneath buildings. It is a conducive condition for wood-destroying organisms. Recommend grading soil so it slopes down and away from buildings with a slope of at least 1 inch per horizontal foot for at least 6 feet out from buildings.

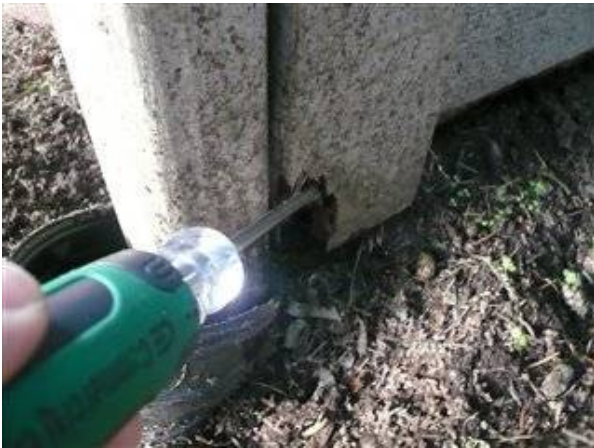
Photo 5-1

5) *Repair/Replace, Damage* - Fungal rot was found at one or more sections of siding or trim, gable ends, exposed beams and/or crawlspace vents. Conducive conditions for rot should be corrected (e.g. wood-soil contact, reverse perimeter slope). Recommend that a qualified person repair as necessary. All rotten wood should be replaced.

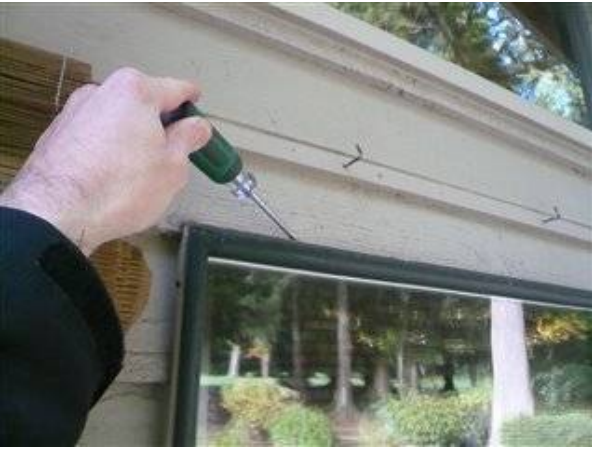
Photo 6-1

6) *Repair/Maintain, Monitor, Conducive conditions* - One or more windows or doors were installed with no "drip cap" or "Z" flashings installed above them. Better building practices call for such flashings, which greatly reduce the chance of leaks above windows and doors. Without this flashing, caulk and paint must be maintained or water can enter the wall structure and cause rot and possible structural damage. Depending on the exposure (e.g. roof overhang, height of exterior wall, direction of prevailing rain) this may or may not be an issue. The client should monitor these areas in the future and maintain caulk and paint as necessary. Consult with a qualified contractor about installing flashings where needed, and per standard building practices. Note that when trim or siding is removed to install flashing, damaged wood may be found and additional repairs may be needed.

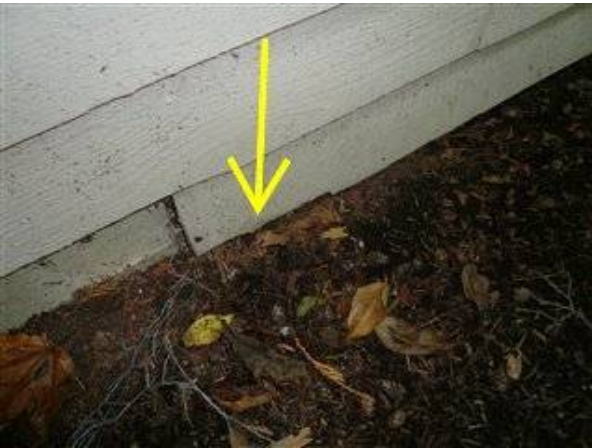
Photo 7-1

7) *Repair/Maintain, Conducive conditions* - Soil was in contact with or less than 6 inches from siding, trim or structural wood. This is a conducive condition for wood-destroying organisms. Recommend grading or removing soil as necessary to maintain a 6-inch clearance. If not possible, then recommend replacing untreated wood with pressure-treated wood. Installation of borate-based products such as Impel rods can also reduce the likelihood of rot or infestation if soil cannot be removed. Note that damage from fungal rot and/or insects may be found when soil is removed, and repairs may be necessary.

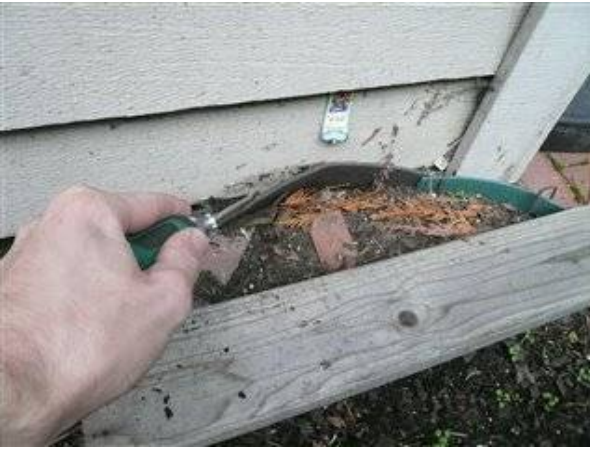
Photo 8-1

8) *Repair/Maintain, Conducive conditions* - One or more planters were in contact with the building exterior. This can result in high levels of moisture at the building exterior near planters. It is a conducive condition for wood-destroying organisms. Recommend removing planters, or repairing so there is a gap of at least 2 inches between planters and the building exterior for better airflow and to allow building exteriors to dry quickly.

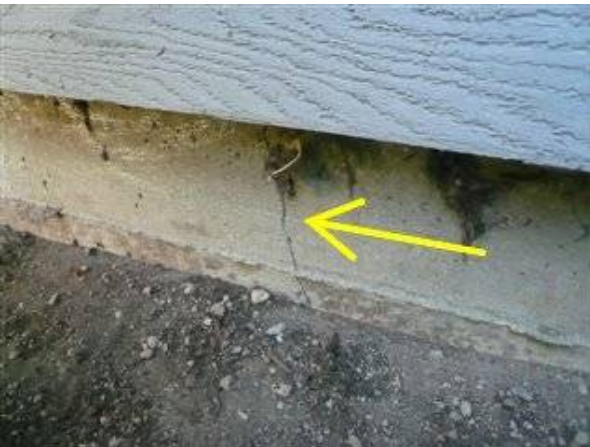
Photo 9-1

9) *Repair/Maintain* - One or more minor cracks (1/8 inch or less) were found in the foundation. These didn't appear to be a structural concern, but recommend sealing them to prevent water infiltration and monitor them in the future. Numerous products exist to seal such cracks including hydraulic cement, non-shrinking grout, resilient caulks and epoxy sealants.

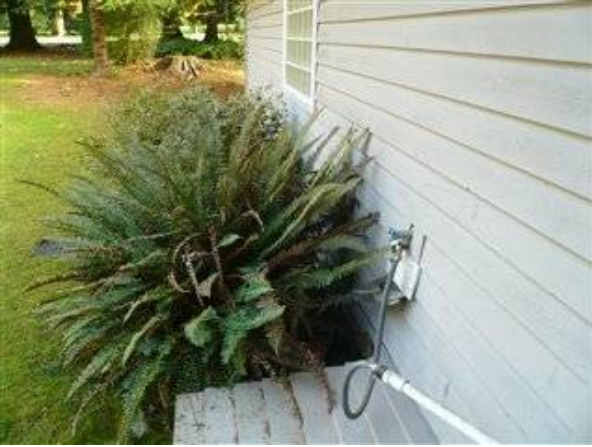
Photo 10-1

10) *Maintain, Conducive conditions* - Vegetation such as trees, shrubs and/or vines was in

contact with or close to the building exterior. Vegetation can serve as a pathway for wood-destroying insects and can retain moisture against the exterior after it rains. This is a conducive condition for wood-destroying organisms. Recommend pruning, moving or removing vegetation as necessary to maintain at least 6 inches of space between it and the building exterior. A 1-foot clearance is better.

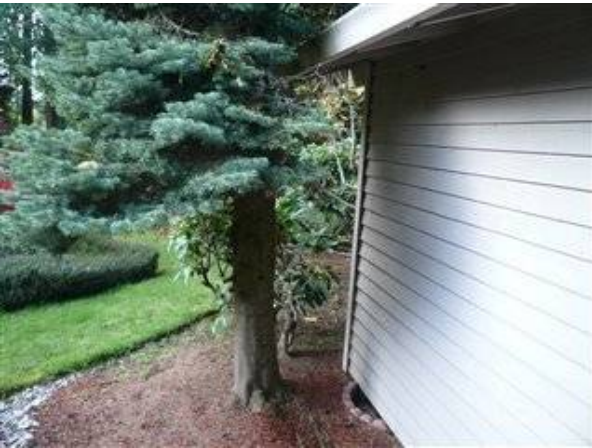
Photo 11-1

11) *Maintain, Conducive conditions* - Significant trees were in contact with or were close to the building at one or more locations. Damage to the building may occur, especially during high winds, or may have already occurred (see other comments in this report). Recommend that a qualified tree service contractor or certified arborist remove trees as necessary to prevent damage to the building exterior.

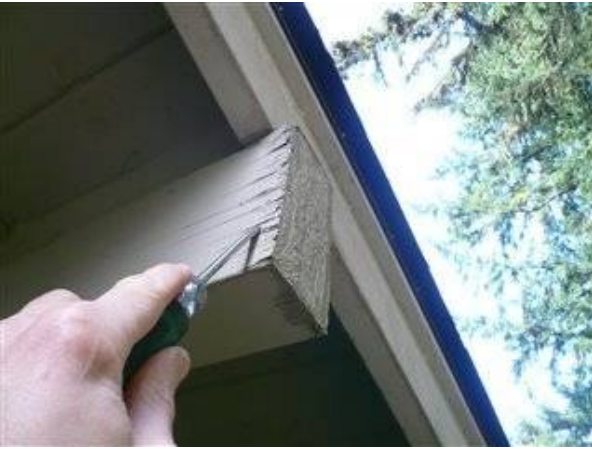
Photo 12-1

12) *Maintain, Conducive conditions* - The paint or stain finish in some areas was failing (e.g. peeling, faded, worn, thinning). Siding and trim with a failing finish can be damaged by moisture. Recommend that a qualified contractor prep (e.g. clean, scrape, sand, prime, caulk) and repaint or restain the building exterior where necessary and per standard building practices. Any repairs needed to the siding or trim should be made prior to this.

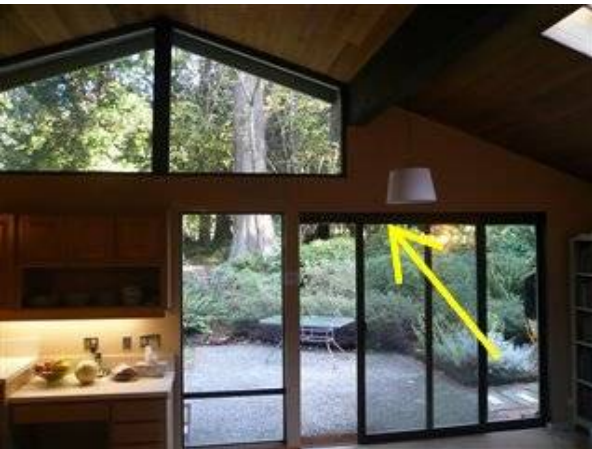
Photo 13-1

13) *Evaluate* - The East facing gable wall at the south end of the home should be evaluated by a qualified contractor or engineer. The inspector was unable to determine if proper bearing points and point loads were in place to carry the load of the roof beams above. Minor cracking was noted on the interior surface at window corners but no signs of significant structural movement or failure were noted.

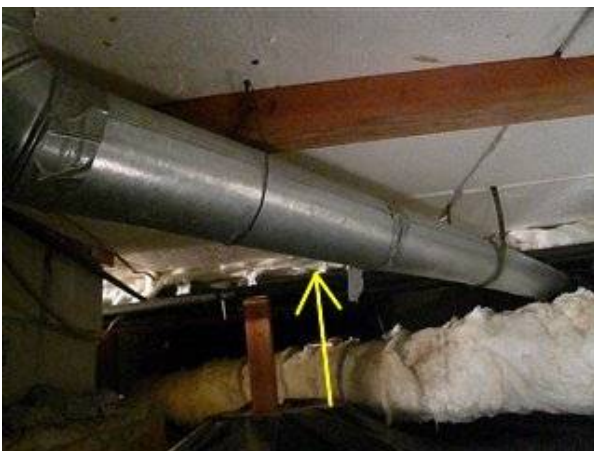
Photo 14-1

14) *Repair/Replace* - One or more exhaust ducts (e.g. kitchen fan, clothes dryer) in the crawl space were not insulated. This can result in moisture forming inside the duct or "sweating" on the outside of the duct depending on the surrounding air temperature and the exhaust air temperature. Recommend that a qualified person install insulation on exhaust ducts per standard building practices (typically R-4 rating), or replace uninsulated ducts with insulated ducts.

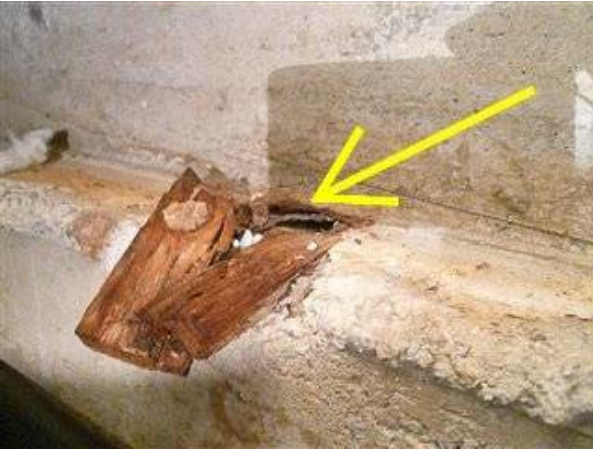
Photo 15-1

15) *Minor Defect, Conducive conditions* - Cellulose material such as form wood was found in the crawl space. This is a conducive condition for wood-destroying organisms. Recommend removing all cellulose-based debris or stored items.

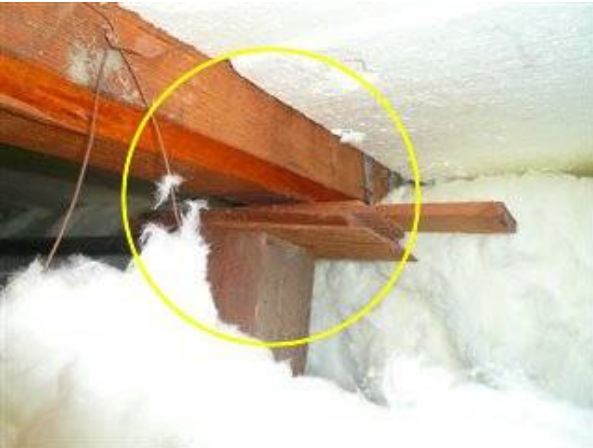
Photo 16-1

16) *Evaluate* - There is a support post in an inaccessible area between duct work in the center of the home which appears to have no contact with the beam above. The inspector was not able to view the base of this post to determine it's significance in the home's structure. Recommend a qualified contractor evaluate and repair as necessary.

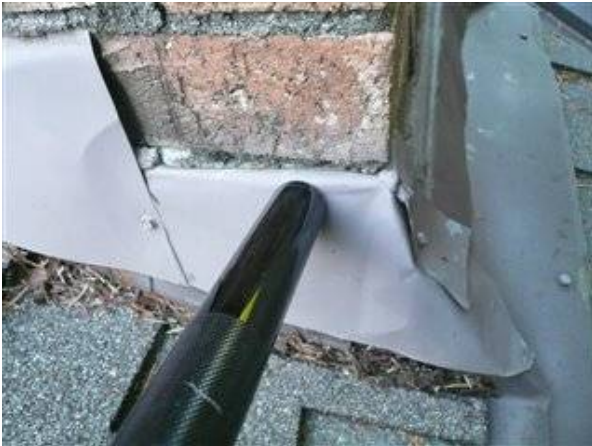
Photo 18-1

18) *Repair/Replace, Evaluate, Conducive conditions* - Flashings at the base of both chimneys were loose and/or deteriorated. Leaks can occur as a result. This is a conducive condition for wood-destroying organisms. Recommend that a qualified contractor evaluate and repair as necessary.

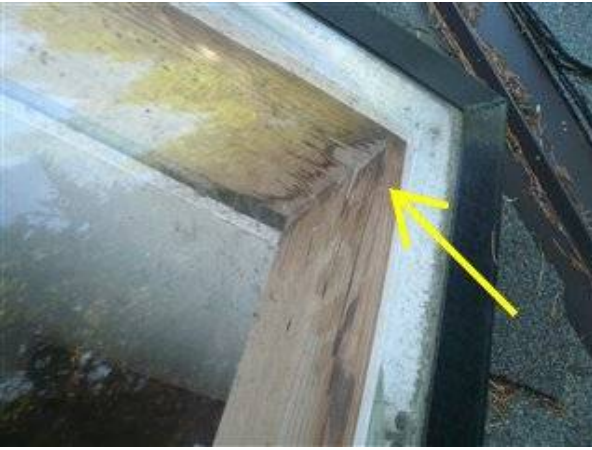
Photo 19-1

19) *Repair/Replace, Evaluate* - Water damage and/or evidence of past leaks was found at one or more skylights. Consult with the property owner to determine if leaks have occurred, or if repairs have been made. Recommend that a qualified contractor evaluate and repair as necessary.

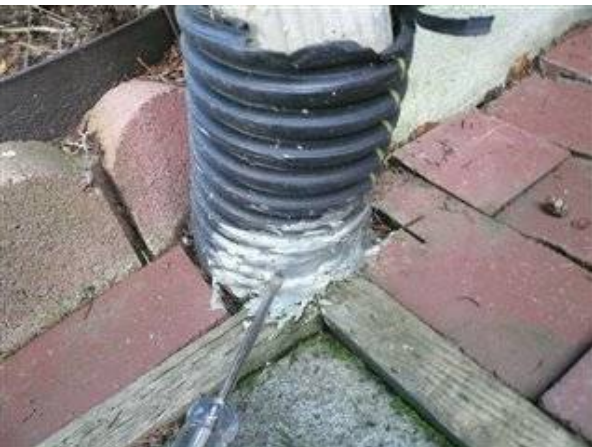
Photo 20-1

20) *Repair/Replace* - Drain pipes for one or more downspouts were damaged. Water can accumulate around the building foundation or inside crawl spaces or basements as a result. Recommend that a qualified person install, replace or repair extensions as necessary so rainwater drains away from the structure.

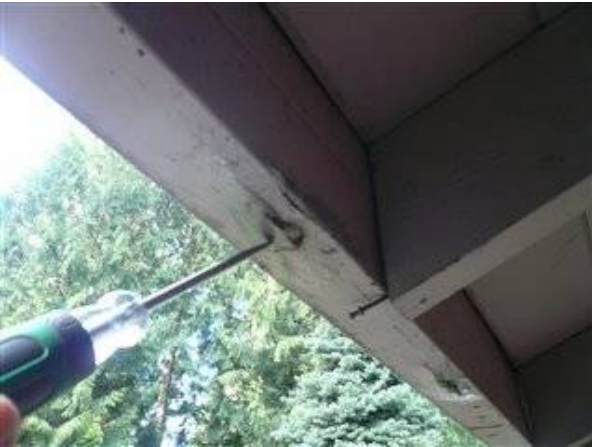
Photo 21-1

21) *Repair/Maintain, Conducive conditions* - One or more gutters were leaking. Rainwater may come in contact with the building exterior or accumulate around the foundation as a

result. This is a conducive condition for wood-destroying organisms. Recommend that a qualified person repair as necessary.

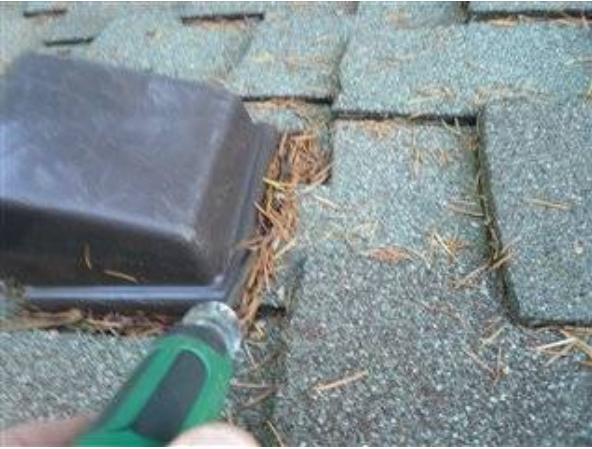
Photo 22-1

22) *Maintain, Conducive conditions* - Significant amounts of debris such as leaves, needles, seeds, etc. have accumulated on the roof surface. Water may not flow easily off the roof, and can enter gaps in the roof surface. Leaks can occur as a result. This is a conducive condition for wood-destroying organisms. Recommend cleaning debris from the roof surface now and as necessary in the future.

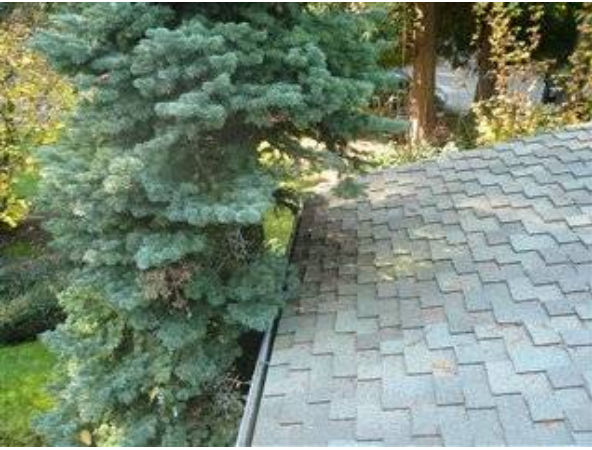
Photo 23-1

23) *Maintain, Conducive conditions* - Vegetation such as trees, shrubs, and/or vines overhung the roof surface or were in contact with the roof edge. Organic debris such as leaves or needles are likely to accumulate in gutters and on the roof surface. Gutters can overflow and cause water to come in contact with the building exterior or water can accumulate around the foundation. This is a conducive condition for wood-destroying organisms. Vegetation in contact with the roof can damage the roof surface and/or the roof drainage system. Recommend pruning vegetation so as to not be in contact with the roof and to not overhang the roof surface. If vegetation is too tall then it should be pruned at least 10 feet above the roof surface.

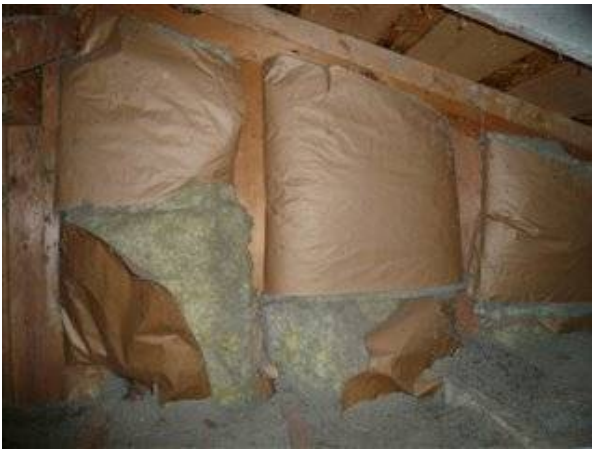
Photo 24-1

24) *Safety, Repair/Replace, Evaluate, Conducive conditions* - The facing on fiberglass batt insulation in the attic was exposed. In most cases, the facing is flammable and poses a fire hazard. Also, the facing typically acts as a vapor barrier, and if located away from the interior surfaces can trap moisture from condensation in the cavity between the facing and the interior spaces. This can be a conducive condition for wood-destroying organisms. Recommend that a qualified person repair as necessary. For example, by reinstalling or replacing insulation per standard building practices and per the manufacturer's instructions.

Note that the inspector was unable to evaluate areas obscured by insulation to determine if any damage (e.g. rot, insect infestation) has already occurred due to moisture accumulation. When insulation repairs are made, recommend that the exposed structure be evaluated and repairs made if necessary.

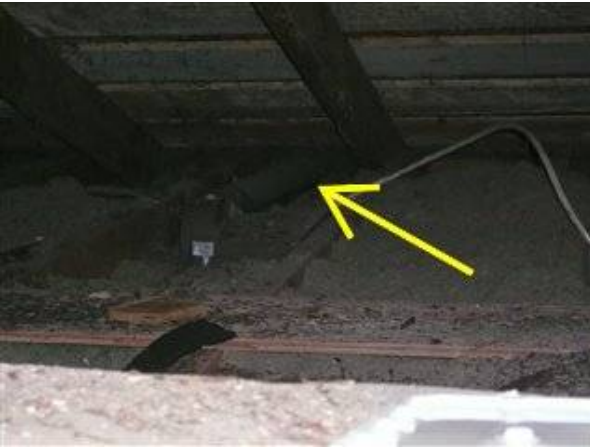
Photo 26-1

26) *Repair/Replace* - One or more exhaust fan ducts terminated at a soffit vent rather than at a dedicated hood or cap. Soffit vents are designed to allow cool air to be drawn into the attic, and to prevent excess moisture from accumulating in the attic. When such ducts are routed to terminate at soffit vents, the moist exhaust air may flow back into the attic and the soffit venting will be reduced. Recommend that a qualified contractor repair per standard building practices. For example, by installing approved hoods or caps at the roof surface or exterior wall(s), and permanently securing exhaust ducts to them.

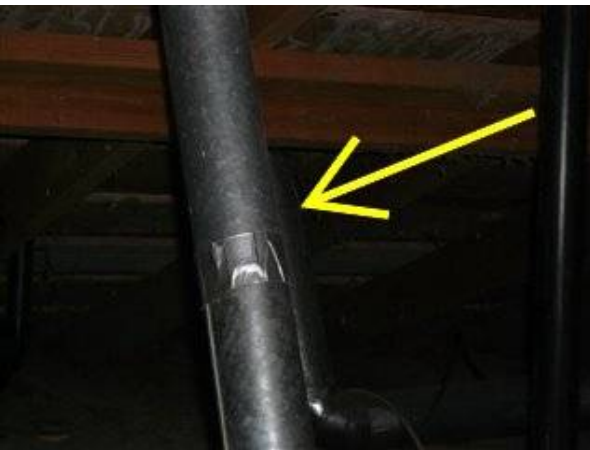
Photo 27-1

27) *Repair/Replace* - One or more exhaust ducts (e.g. bathroom fan) in the attic were not insulated. This can result in moisture forming inside the duct or "sweating" on the outside of the duct depending on the surrounding air temperature and the exhaust air temperature. Recommend that a qualified person install insulation on exhaust ducts per standard building practices (typically R-4 rating), or replace uninsulated ducts with insulated ducts.

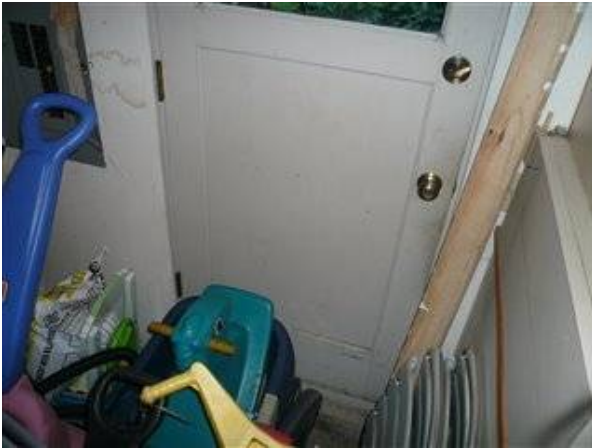
Photo 29-1

29) *Comment* - The garage exterior entry door was obscured by stored items. The inspector was unable to operate or fully evaluate the door(s) as a result.

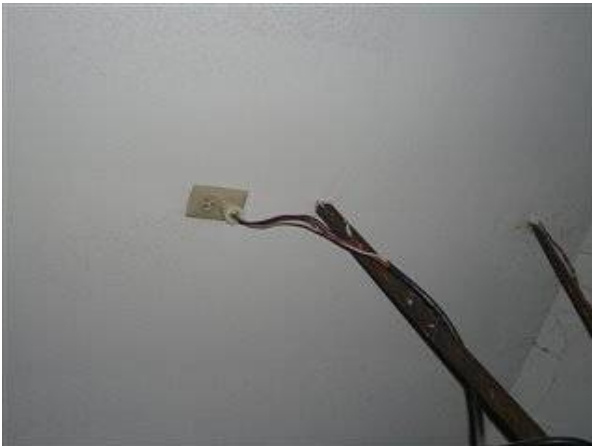
32) *Safety, Repair/Replace, Evaluate* - Substandard wiring was found at the attic, crawl space, interior rooms and/or garage. For example, exposed wiring, loose wiring, unterminated wires, exposed splices and/or extension or lamp cord used as permanent wiring. This is a safety hazard. Recommend that a qualified electrician evaluate and repair as necessary and per standard building practices.

Photo 32-1
Extension cord used at garage door opener w/ unprotected wires.

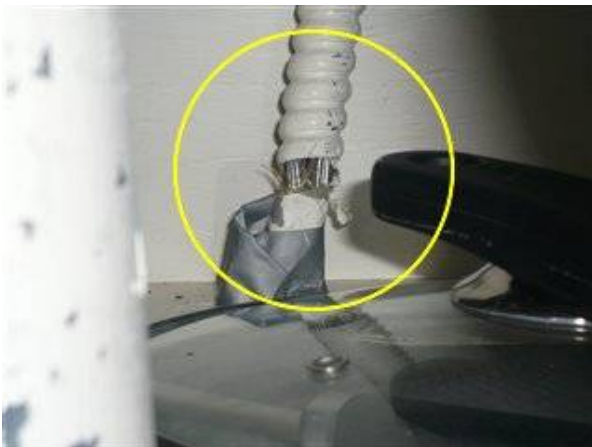
Photo 32-3
Damaged shielding/exposed wires in cabinet below cooktop.

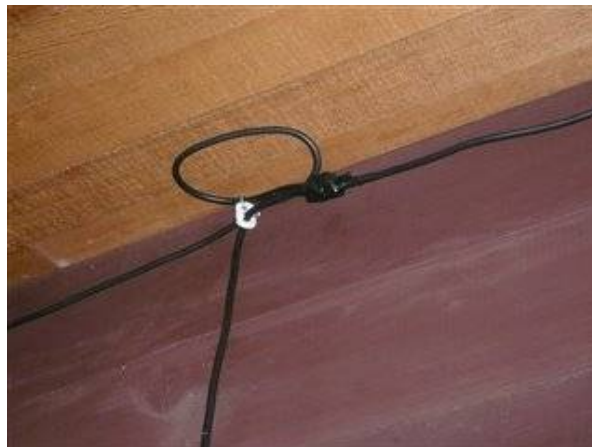
Photo 32-4
Extension cords used at permanent lighting in living room.

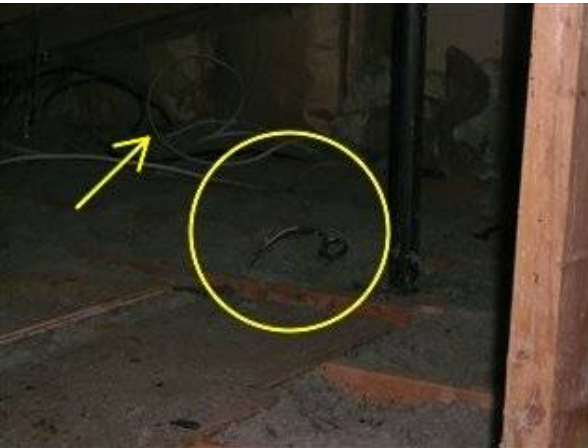
Photo 32-7

Unprotected non-metallic sheathed wiring in pantry.

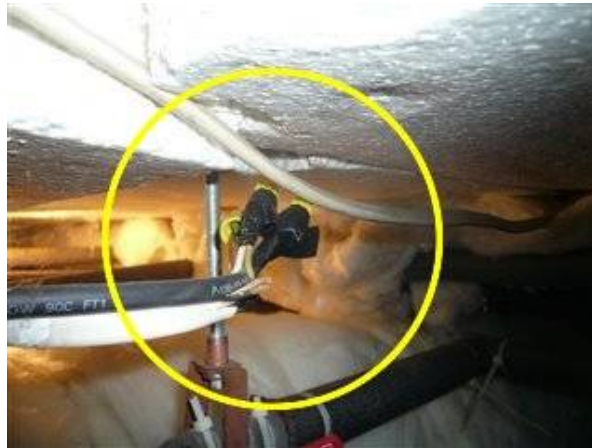
Photo 32-8

Unterminated wire and loose wiring in the attic.

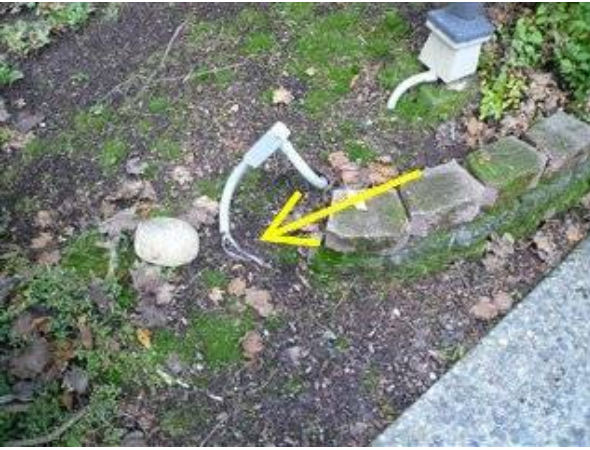
Photo 34-1

34) *Safety, Repair/Replace* - One or more sections of outdoor wiring were exposed and subject to damage. This is a potential shock hazard. Recommend that a qualified electrician repair per standard building practices. For example, by installing conduit, re-routing wires or replacing wiring.

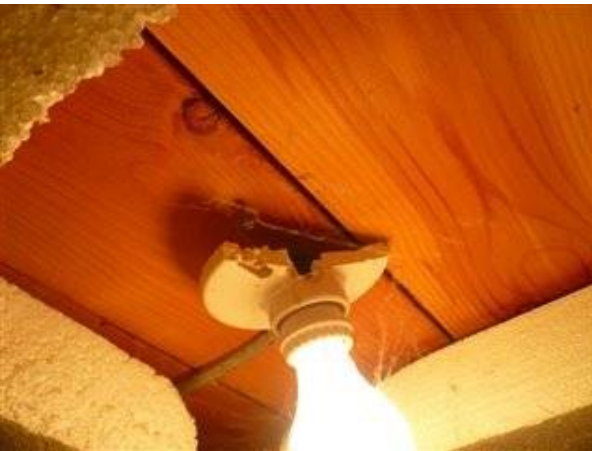
Photo 35-1

35) *Repair/Replace* - One or more light fixtures in the crawlspace were damaged. Recommend that a qualified electrician repair or replace light fixtures as necessary.

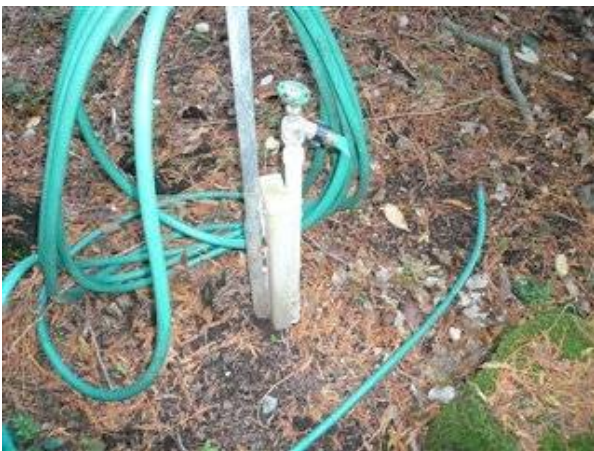
Photo 36-1

36) *Repair/Replace, Evaluate* - Substandard plumbing was noted at the north and south hose bibs. PVC piping was installed and connected to the hose bibs and appeared to be routed to remote hose bibs in the yard. The PVC piping was not properly supported and is subject to damage. At a minimum this piping needs to be disconnected and drained in the winter to avoid freezing. A qualified plumber should evaluate the system and repair or replace as necessary per standard building practices.

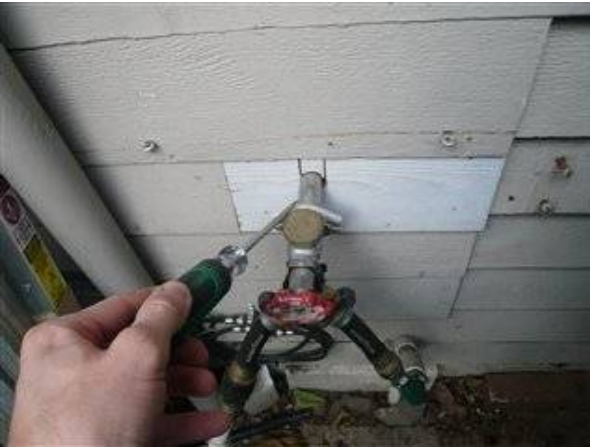
Photo 37-1

37) *Minor Defect* - One or more hose bibs (outside faucets) weren't anchored securely to the structure's exterior. Water supply pipes can be stressed when hose bibs are turned on and off and when hoses are pulled. Leaks may occur as a result. Recommend that a qualified person install fasteners per standard building practices.

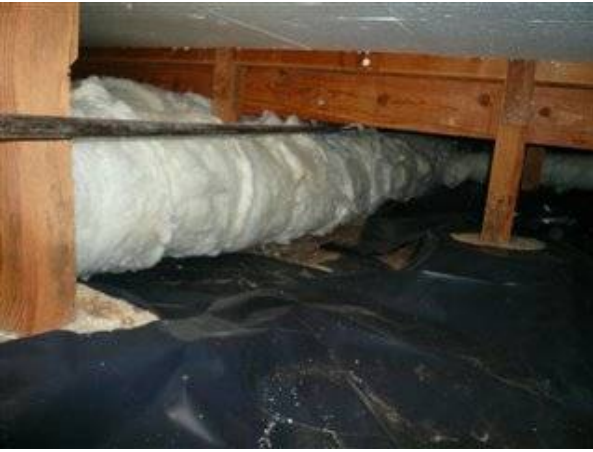
Photo 43-1

43) *Repair/Replace, Evaluate* - One or more heating ducts were lying on the ground. Ducts should be supported (typically with straps or hangers) so that they are not in contact with the ground and subject to damage from moisture. Recommend that a qualified HVAC contractor evaluate and make repairs as necessary so ducts are suspended per standard building practices and are not in contact with the ground.

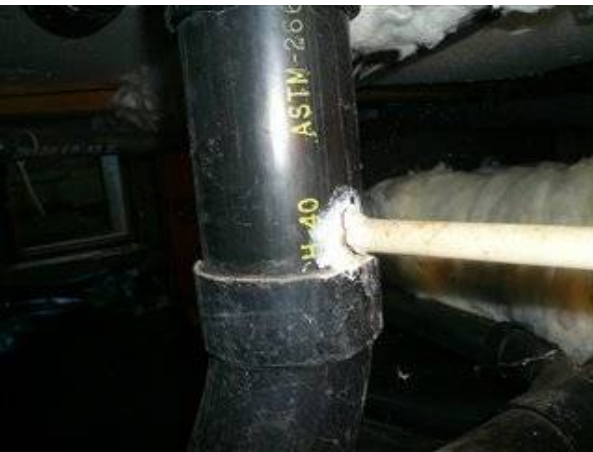
Photo 44-1

44) *Repair/Maintain* - The air handler's primary condensate drain line was routed into a plumbing drain pipe and the connection is substandard. Such drain lines should terminate in surface waterways (e.g. a floor drain, a sink, a sump pump pit, or outside). Sewer gases may enter living spaces. Recommend that a qualified HVAC contractor repair per standard building practices.

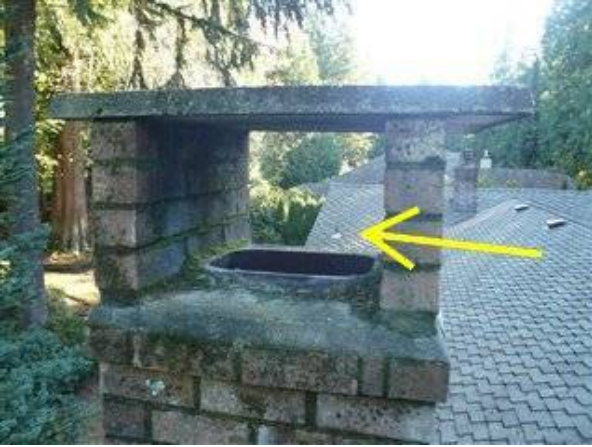
Photo 47-1

47) *Safety, Repair/Maintain* - One or more chimney flue terminations had no spark screen. Spark screens reduce the chance of embers exiting the flue and causing fires. They also prevent wildlife (e.g. birds, rodents, raccoons) from entering flues. Recommend that a qualified person install spark screens per standard building practices where missing.

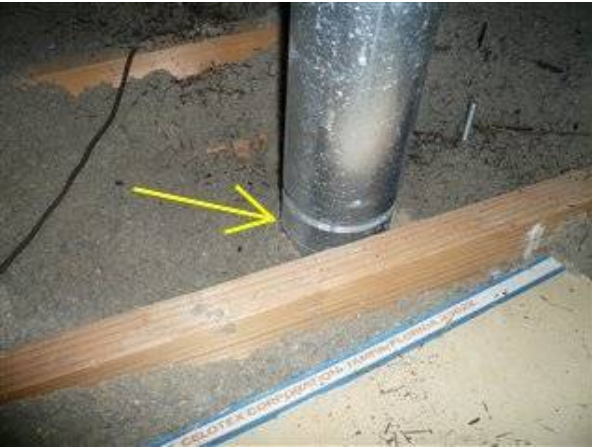
Photo 48-1

48) *Safety, Repair/Maintain* - One or more sections of B-vent metal flue pipe were too close to combustible materials and/or insulation in the attic. This type of vent requires a minimum of 1 inch clearance to such materials. This is a fire hazard. Recommend that a qualified person repair as necessary. For example, by moving insulation, moving the flue pipe, installing a shield or making modifications to surrounding structures.

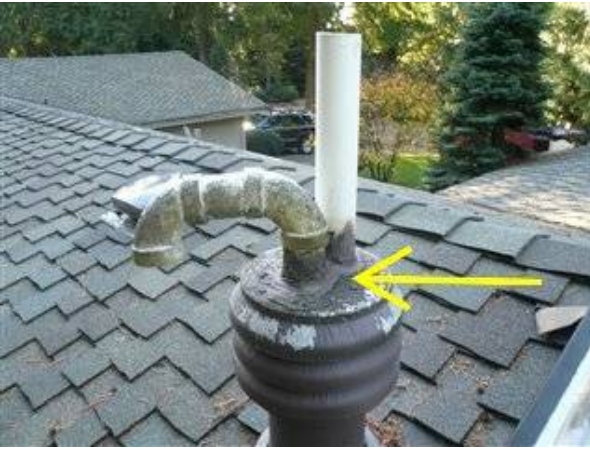
Photo 49-1

49) *Repair/Replace, Conductive conditions* - The PVC combustion air and exhaust venting for the gas furnace was routed through the old metal flue. The exit point at above the roof line is substandard and relying on sealant as a flashing. Leaks can occur if the sealant is not WELL maintained. Recommend a qualified contractor install the proper roof flashings to accept the PVC vent pipes.

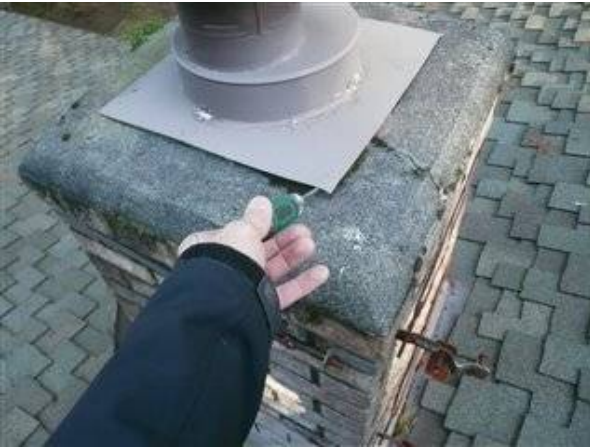
Photo 51-1

51) *Repair/Replace* - Flashing at the base of the metal flue at the south chimney was substandard and may allow moisture to enter. Recommend a qualified contractor repair as necessary per standard building practices.

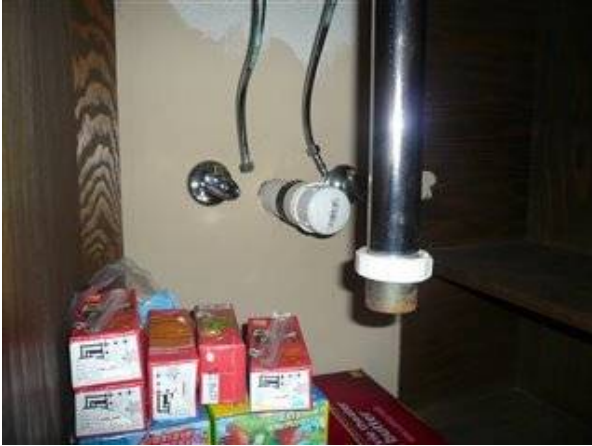
Photo 53-1

53) *Comment* - Supply and drain lines for the bar sink located in the closet off the kitchen were not connected and the inspector was unable to fully evaluate.

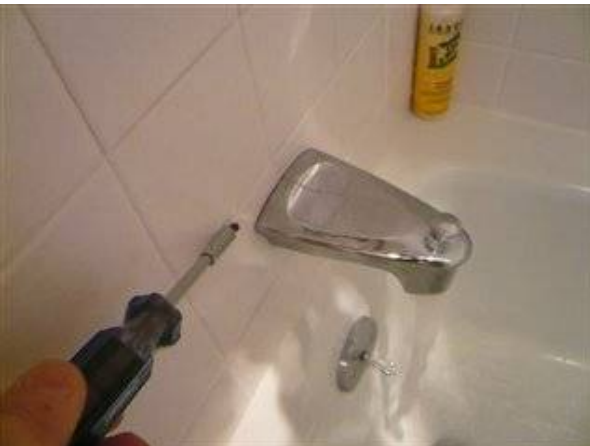
Photo 55-1

55) *Repair/Maintain, Conducive conditions* - Caulk was missing around the base of the bathtub spout, or there was a gap behind it, and the spout was cracked at location(s) #B. Water may enter the wall structure behind the bathtub. Recommend that a qualified person repair as necessary to eliminate the gap. For example, by installing or replacing caulk if the gap is small enough. For larger gaps, a shorter spout nipple or an escutcheon plate can be installed.

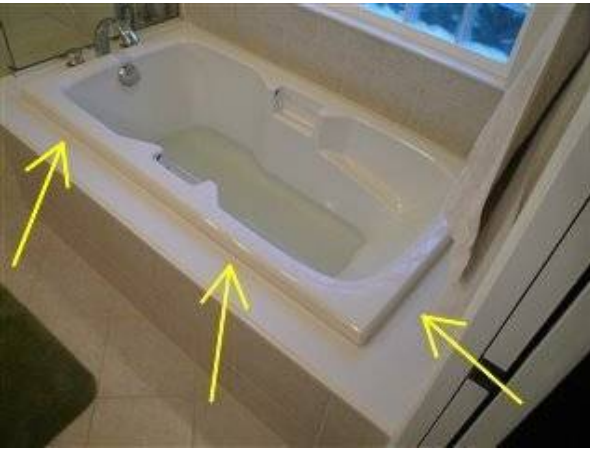
Photo 56-1

56) *Repair/Maintain, Conducive conditions* - Gaps, no caulk, or substandard caulking were found between the bathtub and the surround at location(s) #A. Water may penetrate these areas and cause damage. Recommend that a qualified person re-caulk or install caulking as necessary.

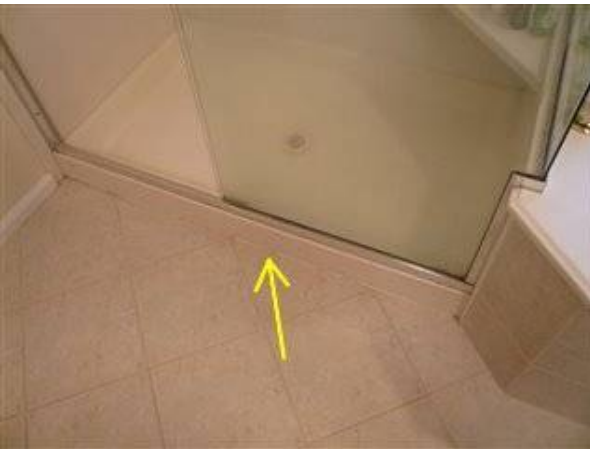
Photo 57-1

57) *Repair/Maintain, Conducive conditions* - Gaps, no caulk, or substandard caulking were found between the shower enclosure and the floor at location(s) #A. Water can penetrate these areas and cause damage. Recommend that a qualified person re-caulk or install caulking as necessary.

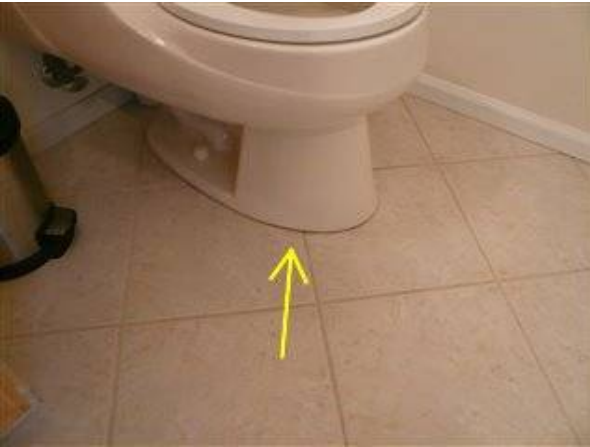
Photo 58-1

58) *Repair/Maintain* - Caulk around the base of the toilet at location(s) #A, #B and/or #C was missing, substandard and/or deteriorated. Modern standards require caulk to be installed around the entire toilet base where it meets the floor for sanitary reasons. Without it, soiled water can soak into flooring and sub-floor materials if the toilet overflows. Condensation from the toilet can also soak into the flooring. Recommend that a qualified person caulk around toilet bases per standard building practices.

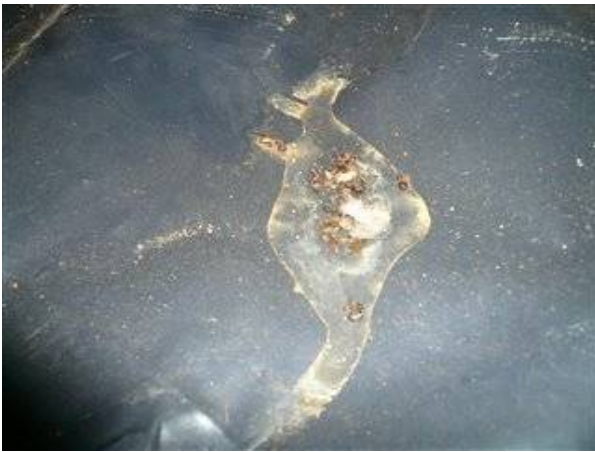
Photo 65-1
Dead carpenter ants.

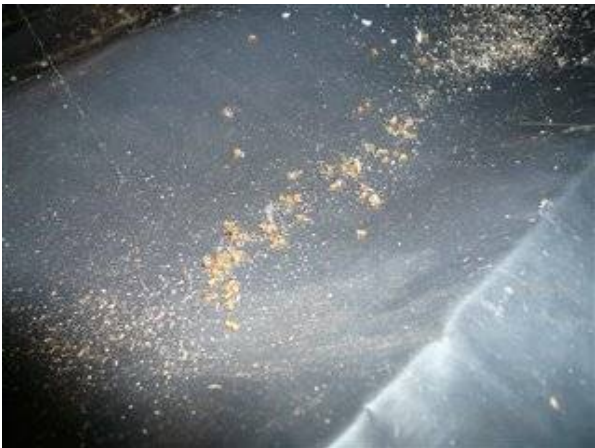
Photo 65-5
Dead moisture ants.

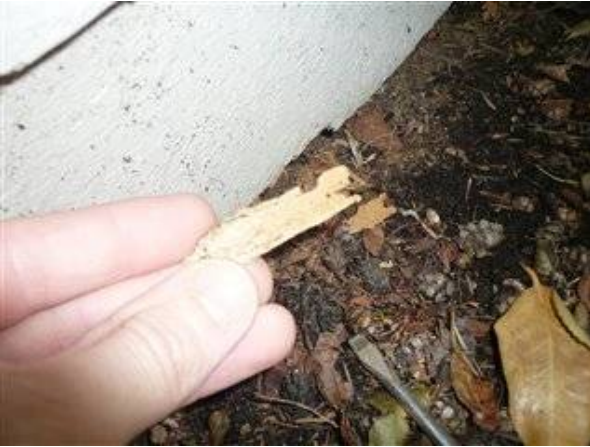
Photo 66-1
Anobiid beetle galleries in damaged siding.

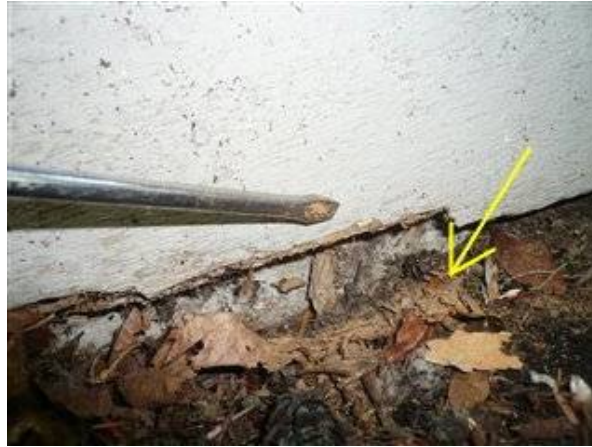
Photo 66-2
Siding damaged by anobiid beetles with frass below.
