Home Inspection Report Structural Pest Inspection Report WSDA Inspection Control Number 4533AQ011

Client(s): Sample

Property address: 1234 Sample Dr W
Sammamish WA 98074-6303

Inspection date: Saturday, November 08, 2014

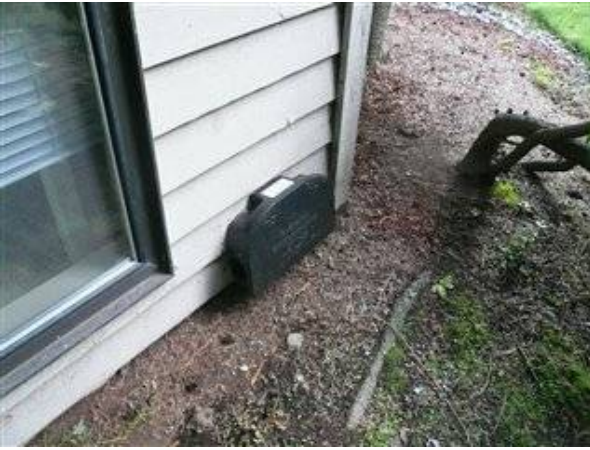
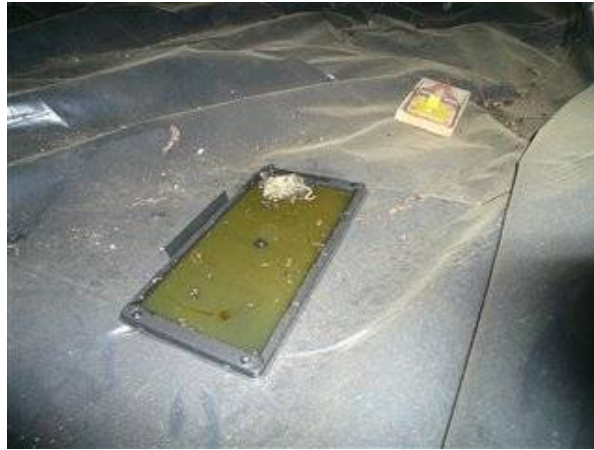
2) *Repair/Replace* - Evidence of rodent infestation was found in the form of traps and/or dead rodents in the crawlspace, attic and the exterior. Consult with the property owner about this. A qualified person should make repairs to seal openings in the structure, set traps, and clean rodent waste as necessary. Recommend following guidelines in these Center for Disease Control articles:

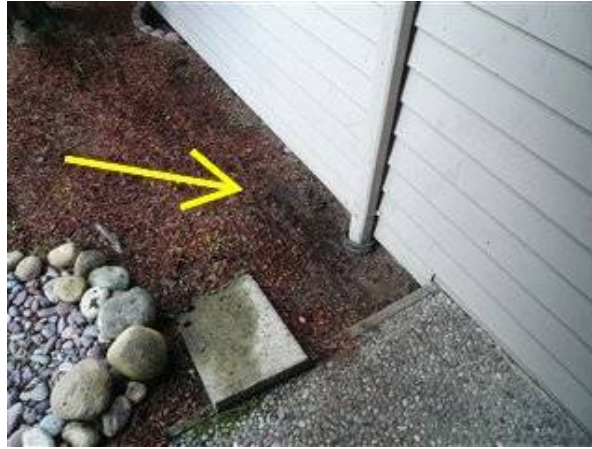
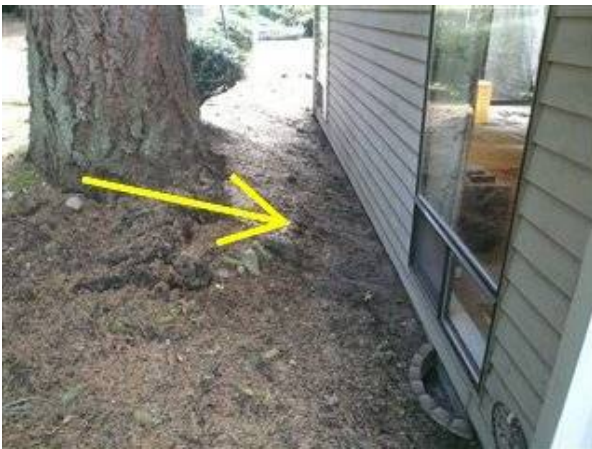
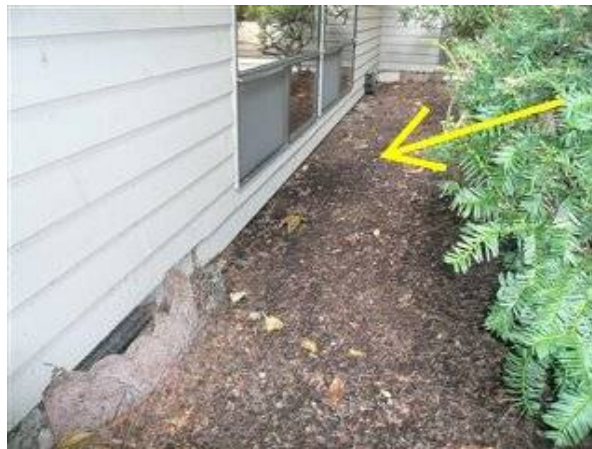
4) *Maintain, Conducive conditions* - The soil or grading sloped down towards building perimeters in one or more areas. This can result in water accumulating around building foundations or underneath buildings. It is a conducive condition for wood-destroying organisms. Recommend grading soil so it slopes down and away from buildings with a slope of at least 1 inch per horizontal foot for at least 6 feet out from buildings.

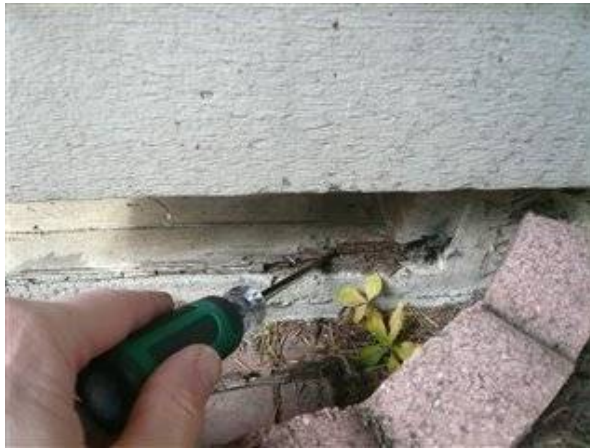
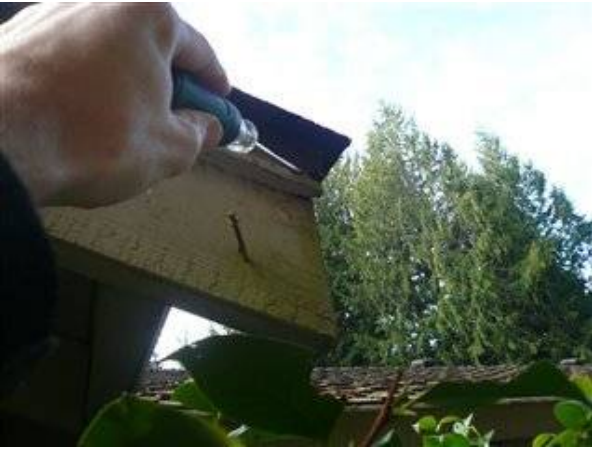
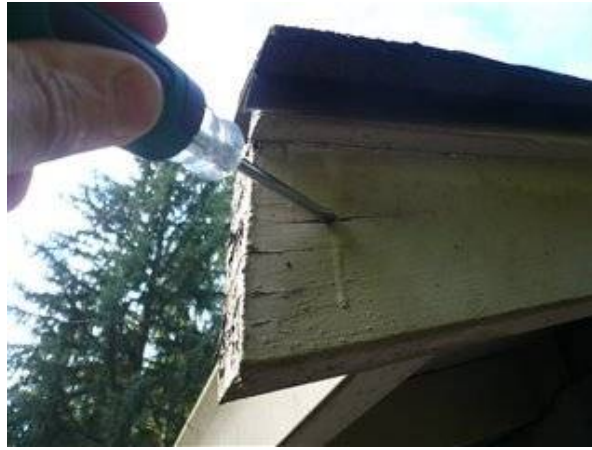
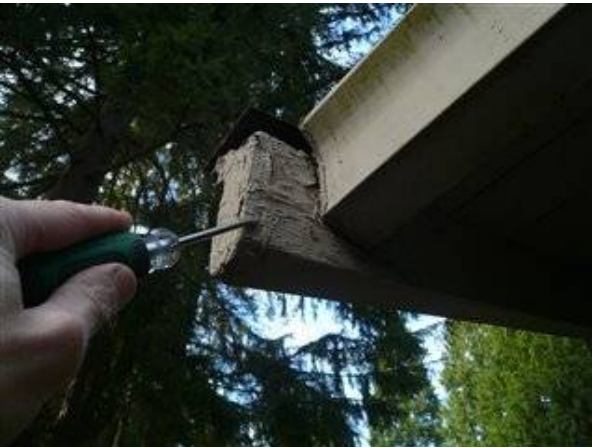
5) *Repair/Replace, Damage* - Fungal rot was found at one or more sections of siding or trim, gable ends, exposed beams and/or crawlspace vents. Conducive conditions for rot should be corrected (e.g. wood-soil contact, reverse perimeter slope). Recommend that a qualified person repair as necessary. All rotten wood should be replaced.

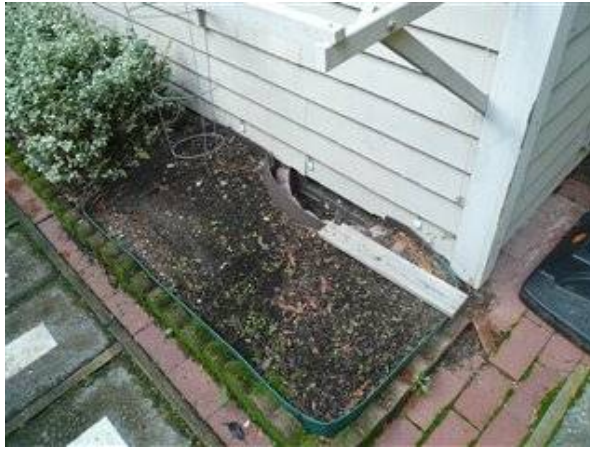
Photo 8-2

8) *Repair/Maintain, Conducive conditions* - One or more planters were in contact with the building exterior. This can result in high levels of moisture at the building exterior near planters. It is a conducive condition for wood-destroying organisms. Recommend removing planters, or repairing so there is a gap of at least 2 inches between planters and the building exterior for better airflow and to allow building exteriors to dry quickly.

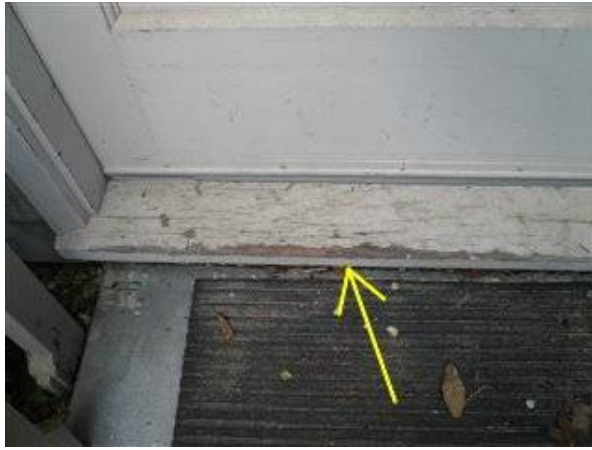
Photo 12-2

12) *Maintain, Conducive conditions* - The paint or stain finish in some areas was failing (e.g. peeling, faded, worn, thinning). Siding and trim with a failing finish can be damaged by moisture. Recommend that a qualified contractor prep (e.g. clean, scrape, sand, prime, caulk) and repaint or restain the building exterior where necessary and per standard building practices. Any repairs needed to the siding or trim should be made prior to this.

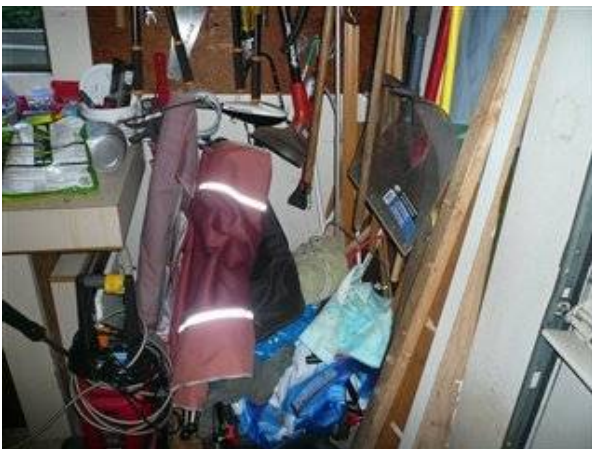
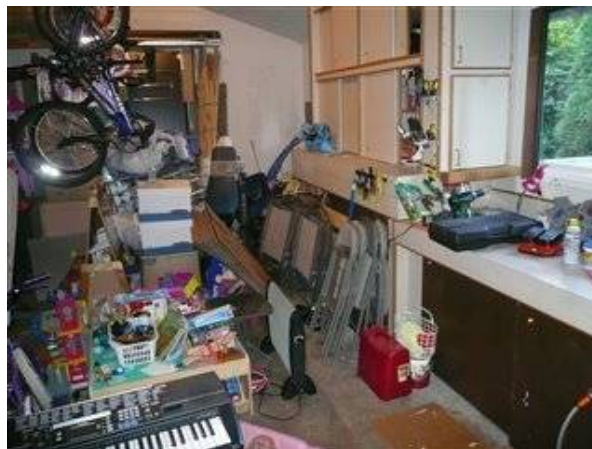
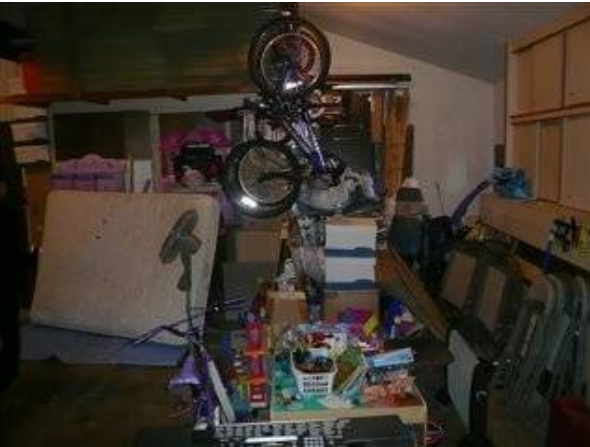
30) *Comment* - Many floor areas were obscured by stored items and couldn't be fully evaluated.

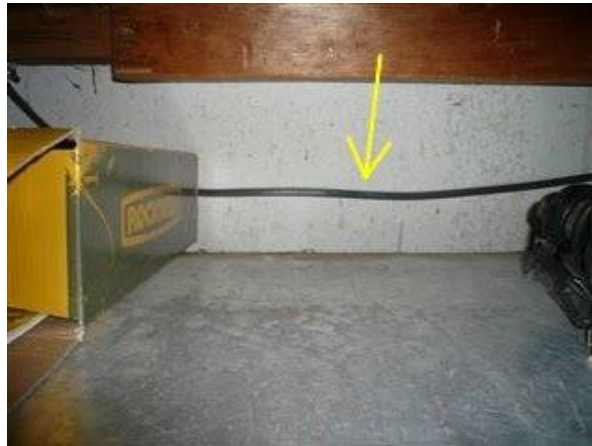
Photo 32-2
Unsupported wiring in garage workbench cabinets.

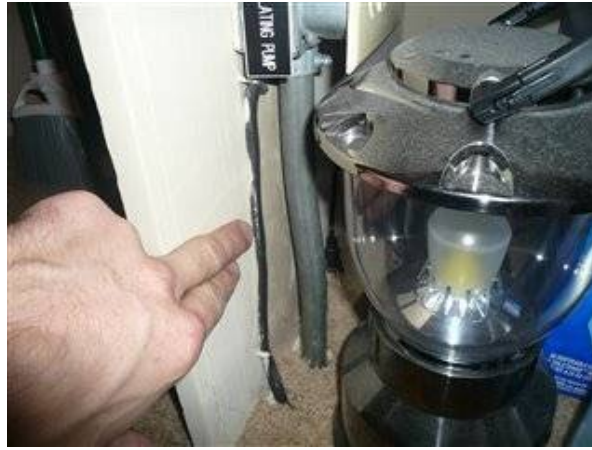
Photo 32-6

Unprotected non-metallic sheathed wiring in pantry.

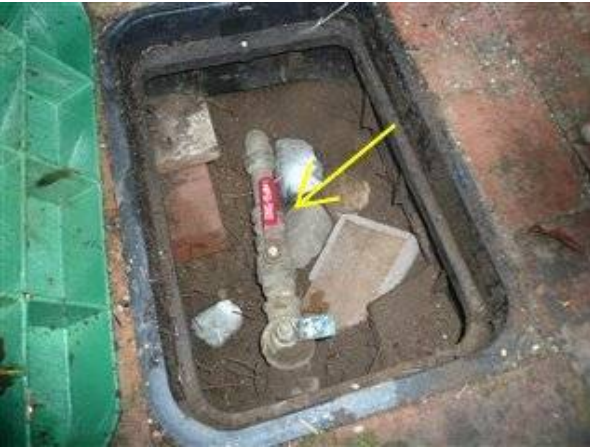
Photo 38-1

38) *Comment* - Main water shut off located in vault at south exterior.

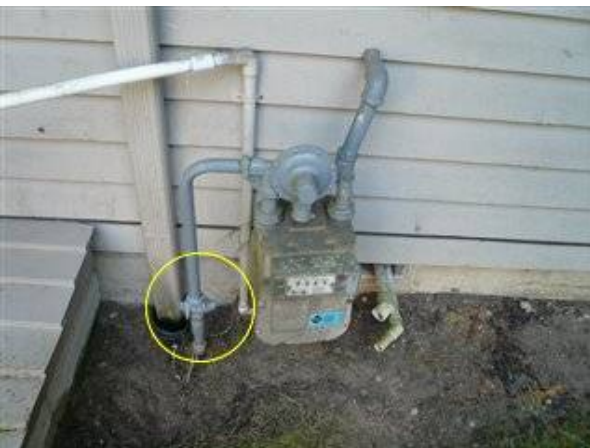
Photo 39-1

39) *Comment* - Main fuel shut-off located at gas meter on north exterior wall.

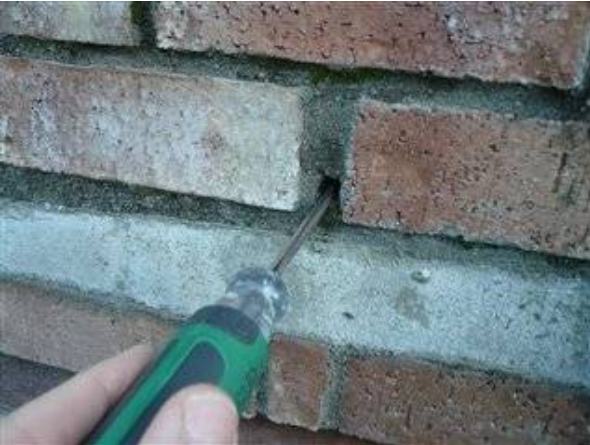
Photo 52-1

52) *Repair/Maintain* - Mortar at the brick chimney was deteriorated (e.g. loose, missing, cracked). As a result, water is likely to infiltrate the chimney structure and cause further damage. Recommend that a qualified contractor repair as necessary. For example, by repointing the mortar.

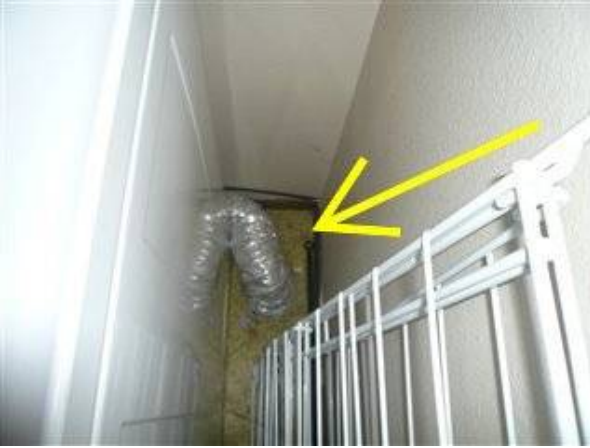
Photo 54-1

54) *Safety, Repair/Replace* - The clothes dryer was equipped with a mylar, accordion-type, flexible exhaust duct. The U.S. Consumer Product Safety Commission considers these types of ducts to be unsafe, and a fire hazard. They can trap lint and are susceptible to kinks or crushing, which can greatly reduce the air flow and cause overheating. Recommend that such ducts be replaced with a rigid or corrugated semi-rigid metal duct, and by a qualified contractor if necessary. For more information, visit:

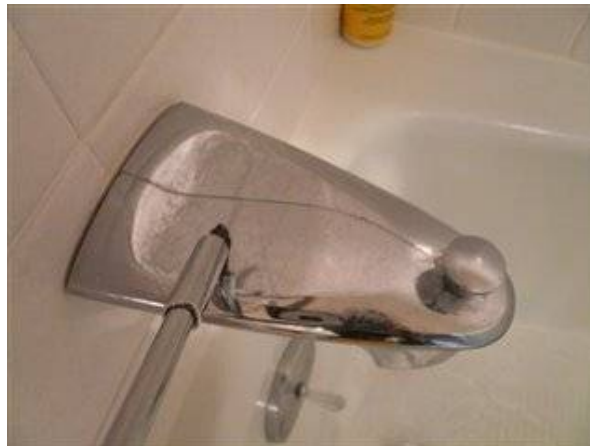
Photo 55-2

55) *Repair/Maintain, Conducive conditions* - Caulk was missing around the base of the bathtub spout, or there was a gap behind it, and the spout was cracked at location(s) #B. Water may enter the wall structure behind the bathtub. Recommend that a qualified person repair as necessary to eliminate the gap. For example, by installing or replacing caulk if the gap is small enough. For larger gaps, a shorter spout nipple or an escutcheon plate can be installed.

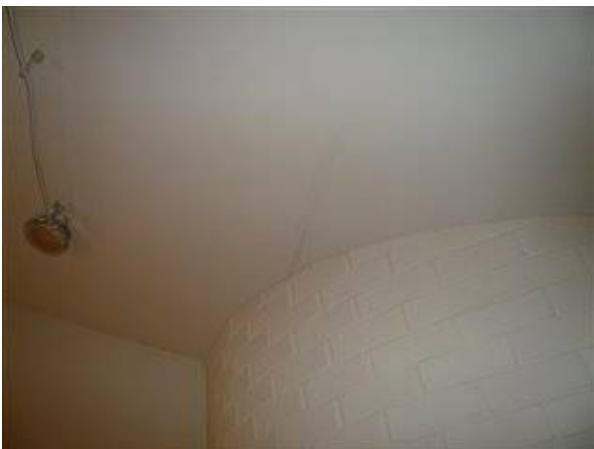
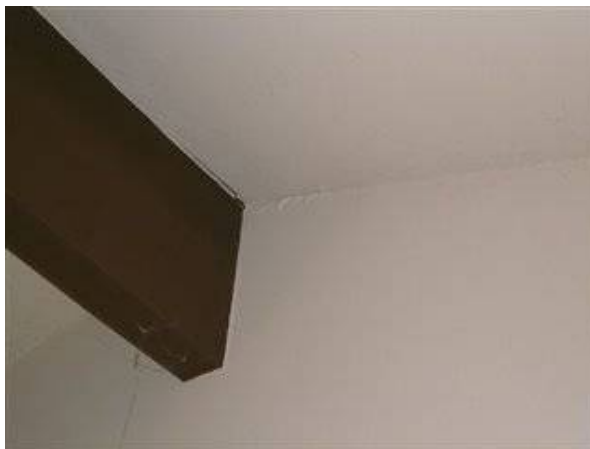
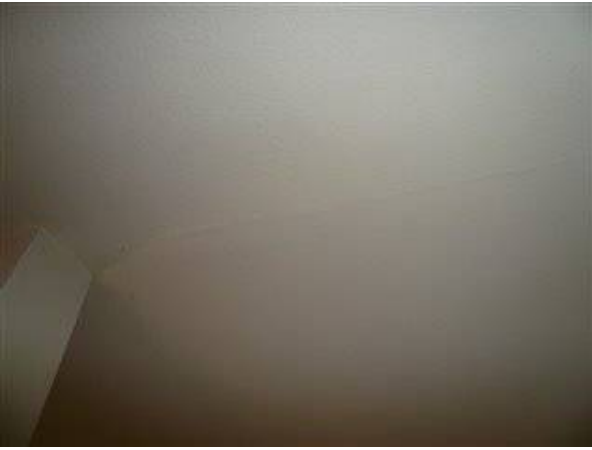
61) *Minor Defect* - Minor cracks, nail pops and/or blemishes were found in walls and/or ceilings in one or more areas. Cracks and nail pops are common, are often caused by lumber shrinkage or minor settlement, and can be more or less noticeable depending on changes in humidity. They did not appear to be a structural concern, but the client may wish to repair these for aesthetic reasons. For recurring cracks, consider using an elastic crack covering product:

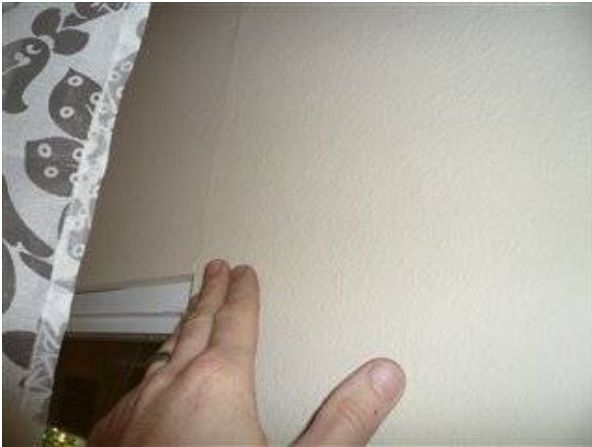
Photo 63-1

63) *Monitor* - Cracks, moisture staining and/or damage were visible at on or more windows. For example the windows on the west facing wall north of the entry door. These are likely from past roof leaks but should be monitored in the future. Ask the seller about any past roof leaks.

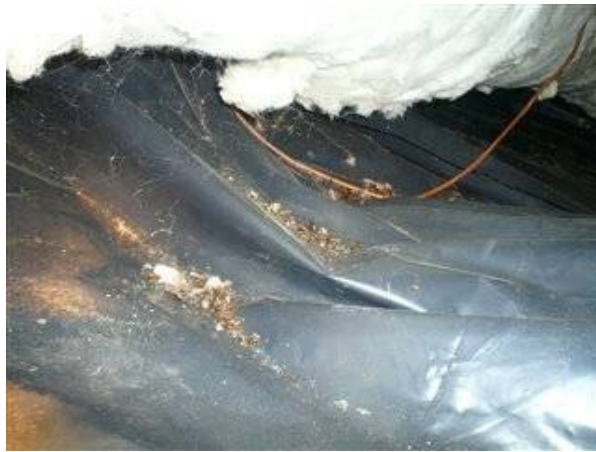
65) *Maintain, Evaluate, Infestation* - Evidence of active infestation of carpenter and/or moisture ants was found at location(s) #B and #C in the form of dead insects or body parts and/or frass with no visible wood damage. Recommend the following:

Photo 65-2
Dead carpenter ants.

- Correct any conducive conditions for wood-destroying organisms mentioned in this report.
- Consult with the property owner about any history of infestation.
- Have a state-licensed pest control operator evaluate further and treat as necessary.

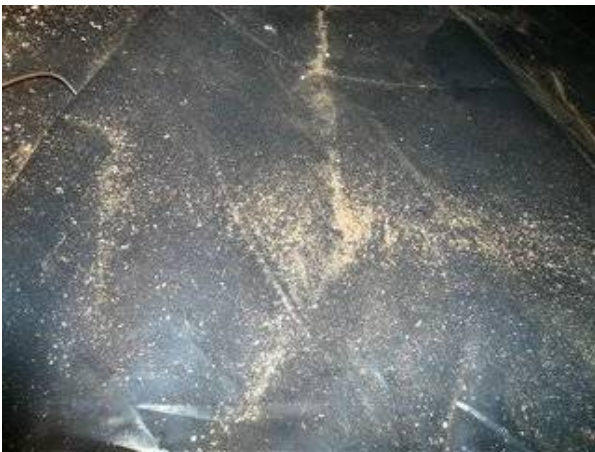
Photo 65-3
Carpenter ant frass.

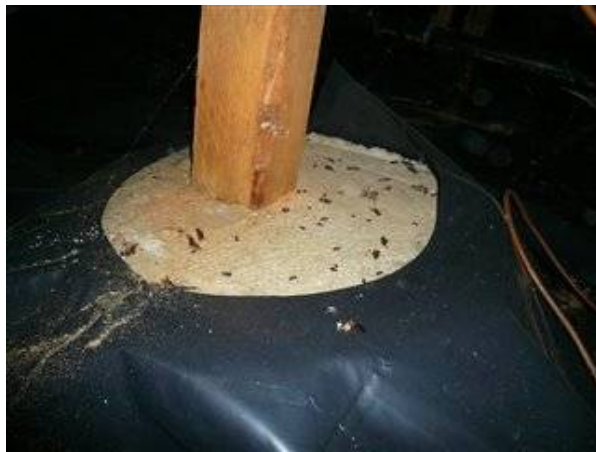
Photo 65-4
Dead carpenter ants.
